# INSPECTION REPORT

For the Property at:  
**5759 HORSE LK**  
100 MILE HOUSE, BC

Prepared for: JOHN DOE  
Inspection Date: Saturday, February 2, 2013  
Prepared by: Daryl Silverton

Report No. 1346, v.6

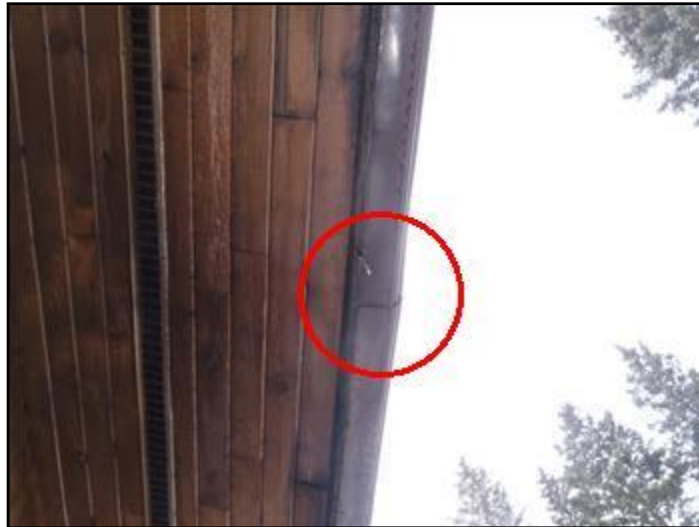
31.

**Condition:** • [Loose or damaged](#)

**Implication(s):** Chance of water damage to contents, finishes and/or structure

**Task:** Improve

**Time:** Discretionary

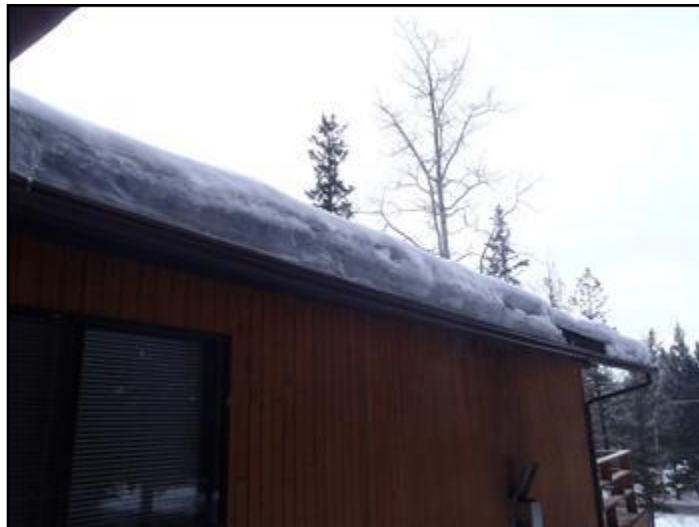
32.

**Condition:** • [Missing](#)

**Implication(s):** Chance of water damage to contents, finishes and/or structure

**Location:** Garage

**Task:** Provide

**Time:** Discretionary

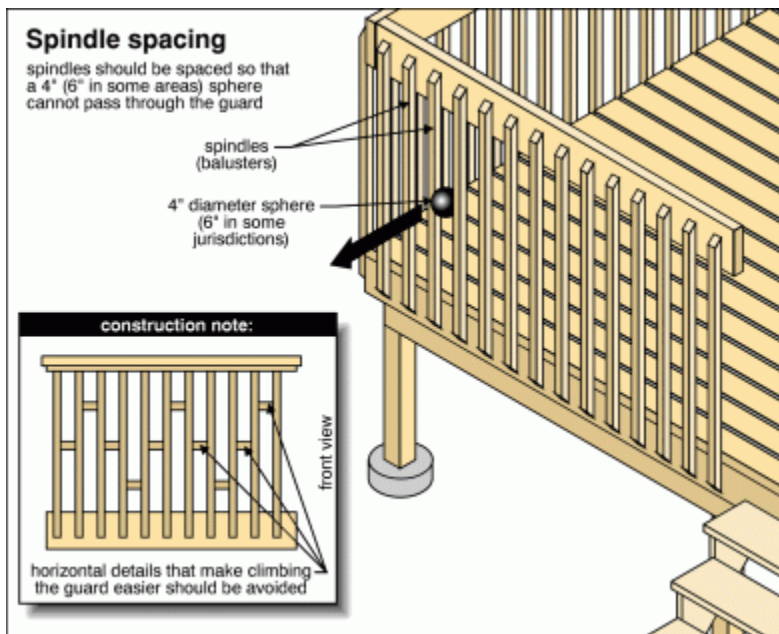
**Condition:** • [Spindles climbable](#)

**Implication(s):** Fall hazard

**Task:** Correct

**Time:** Discretionary

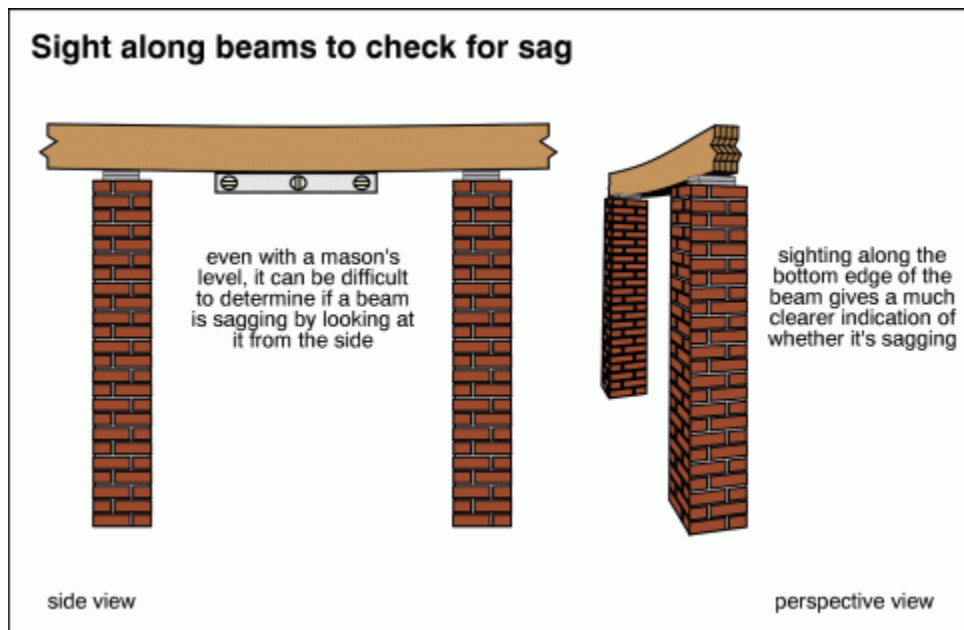
Condition: • [Sag](#)

Appears to have Settled

Implication(s): Weakened structure | Chance of structural movement

Task: Further evaluation

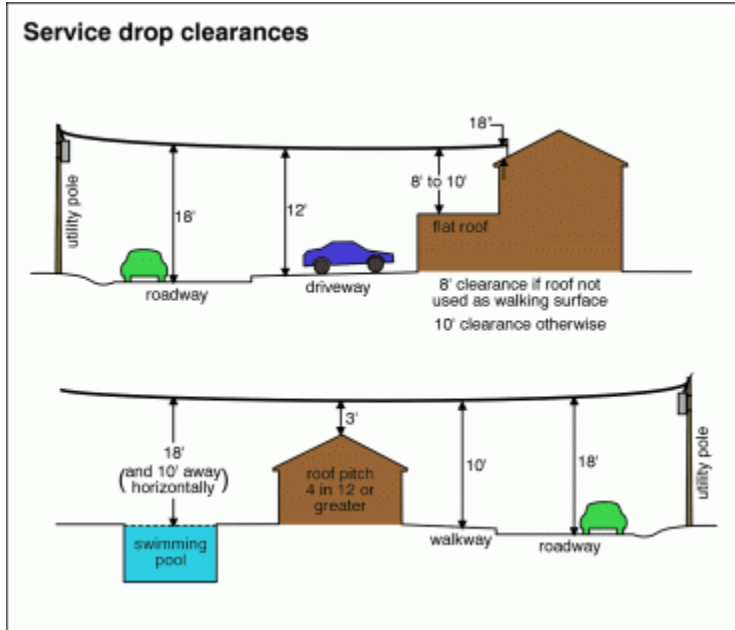
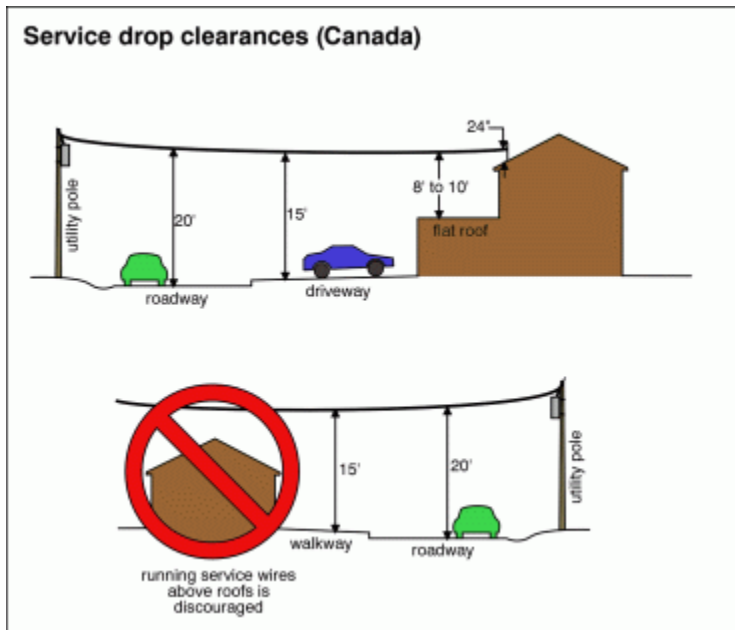
**Condition:** • [Wires too close to roof](#)

## Inadequate wire clearance over roofs

**Task:** Improve

**Time:** Immediate

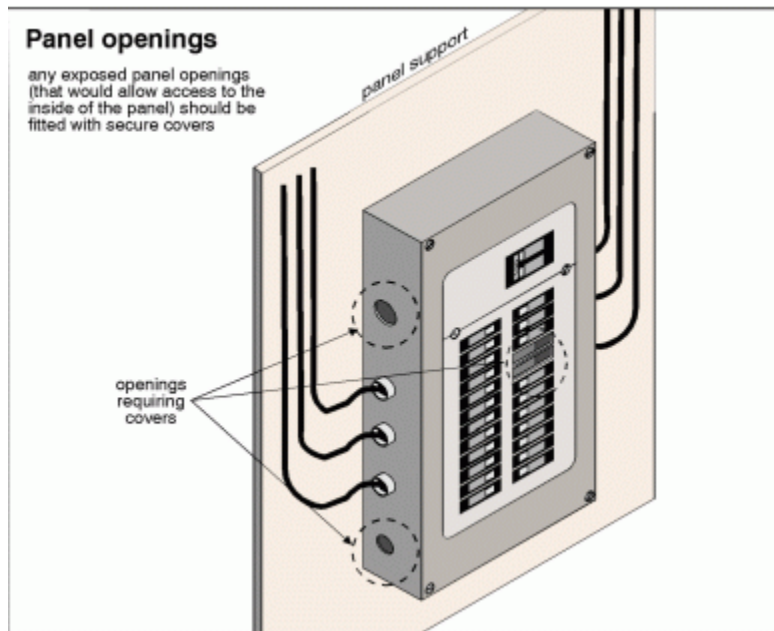
**Condition:** • [Openings in panel](#)

**Implication(s):** Electric shock | Fire hazard

**Task:** Improve

**Time:** Immediate

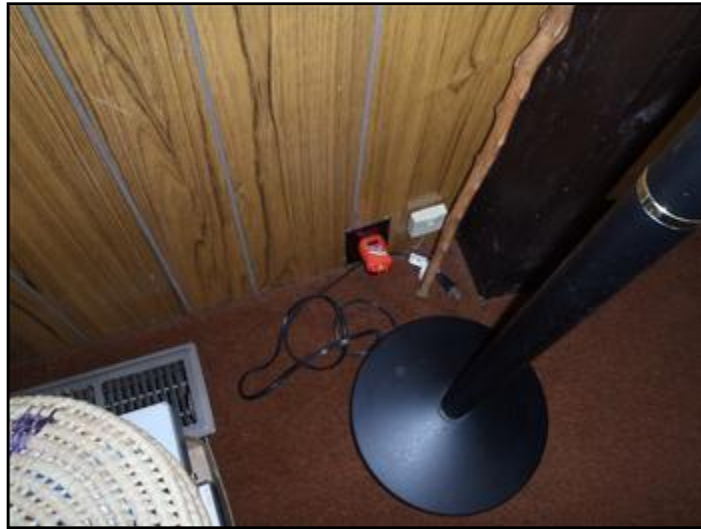
81.

**Condition:** • [Loose](#)

**Implication(s):** Electric shock | Fire hazard

**Task:** Improve

**Time:** Immediate

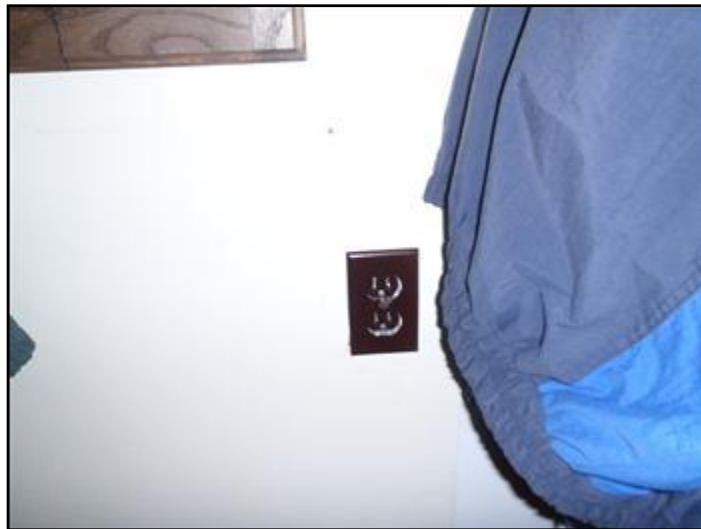
82.

**Condition:** • [No GFI \(Ground Fault Interrupter\)](#)

if there is a difference (even as little as 5 milliamps), there is a current leak (possibly through your body) and the GFI shuts down the receptacle and other receptacles downstream

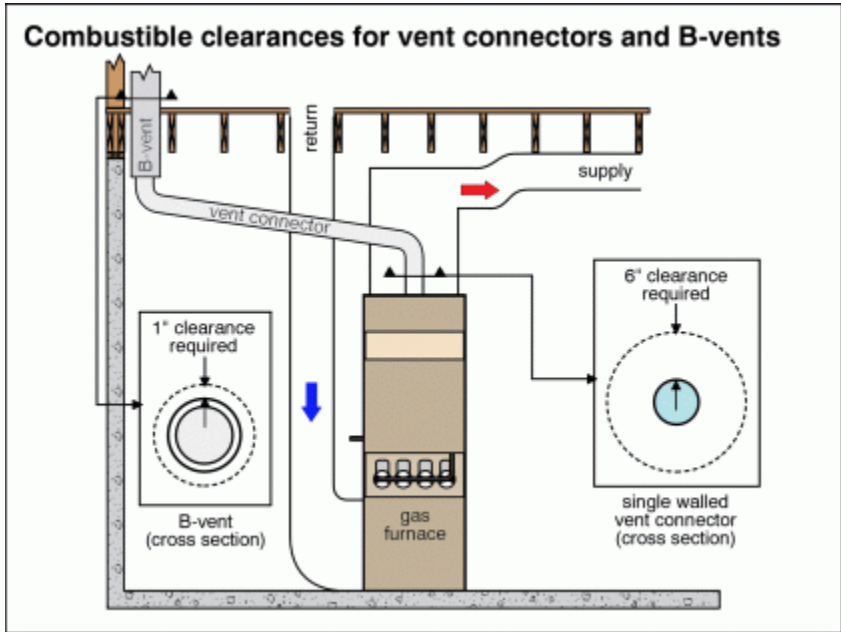
**Condition:** • [Combustible clearance](#)

**Implication(s):** Fire hazard

**Task:** Improve

**Time:** When remodelling

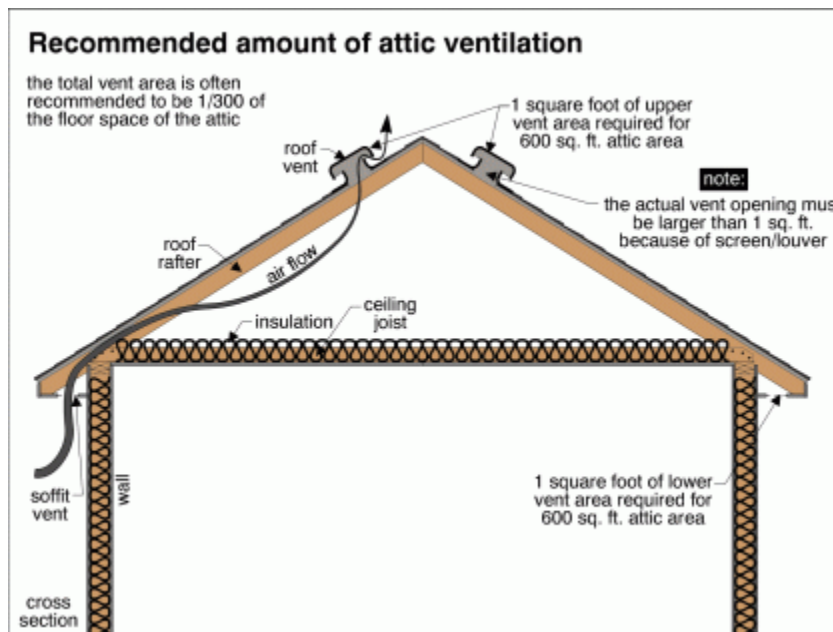
#### Condition: • [Obstructed](#)

**Implication(s):** Chance of condensation damage to finishes and/or structure

**Task:** Improve

**Time:** Less than 1 year

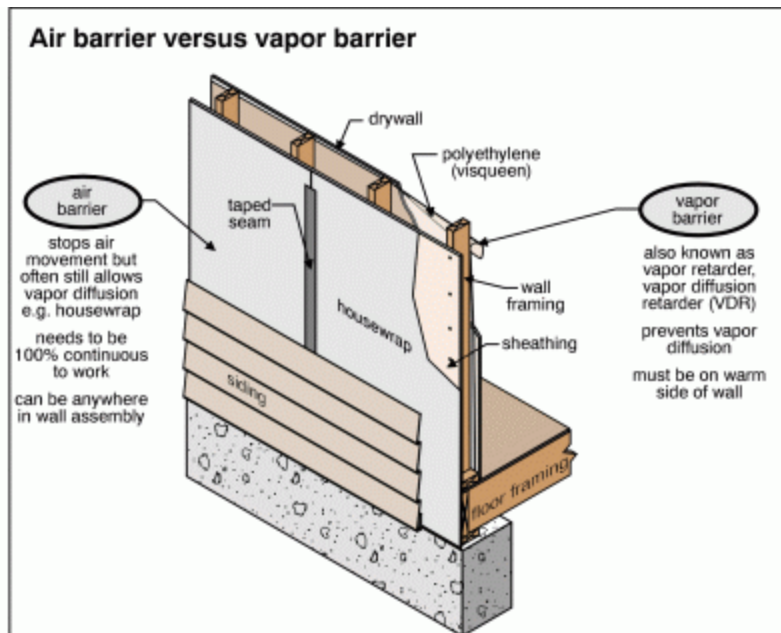
Condition: • [Missing](#)

Implication(s): Chance of condensation damage to finishes and/or structure | Increased heating and cooling costs

Task: Provide

Time: Discretionary

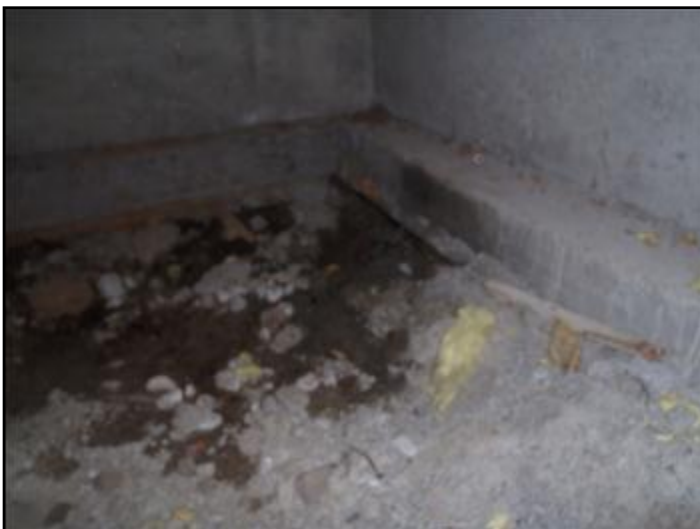
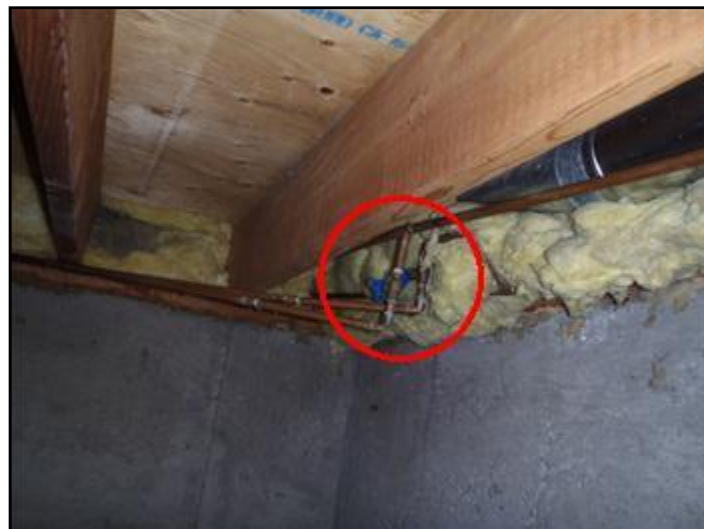
**Condition:** • [Leak](#)

**Implication(s):** Chance of water damage to contents, finishes and/or structure | System inoperative

**Task:** Repair

**Time:** Immediate

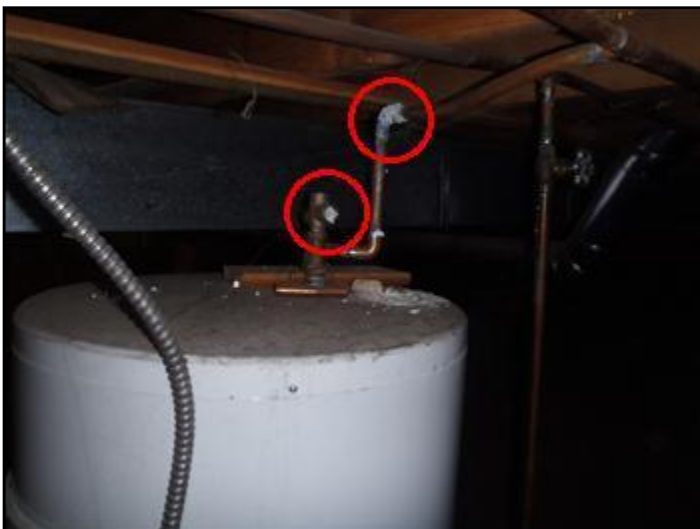
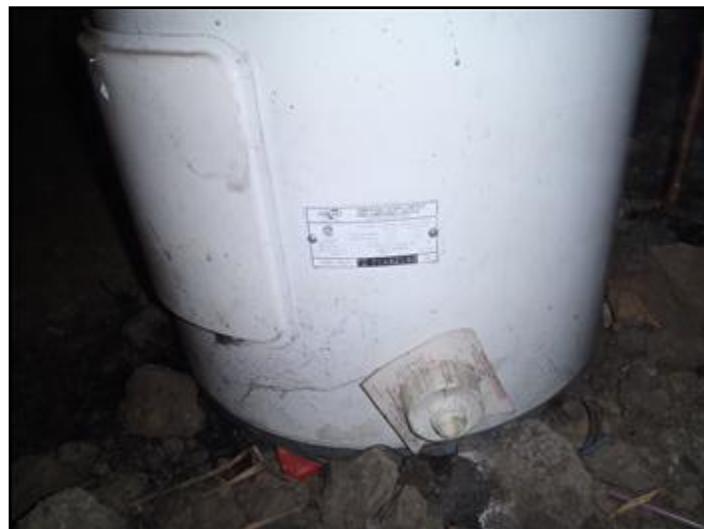
**Condition:** • [Old](#)

**Task:** Replace

**Time:** When necessary

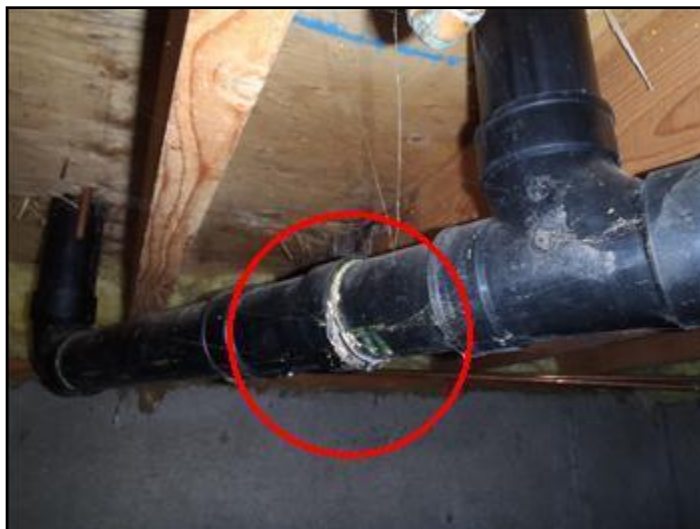
122.

**Condition:** • [Leak](#)

**Task:** Repair

**Time:** Immediate

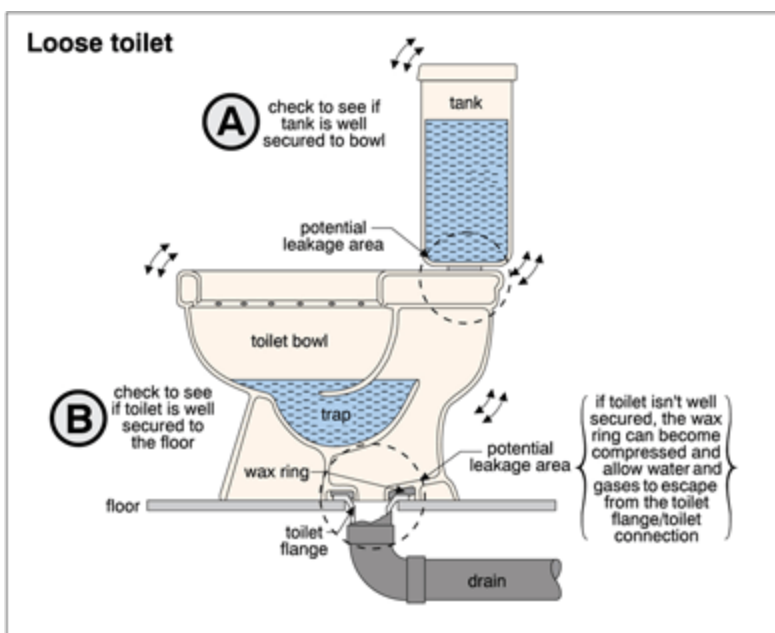
Condition: • [Loose](#)

Implication(s): Chance of water damage to contents, finishes and/or structure | Sewage entering the building

Task: Repair

Time: Less than 1 year

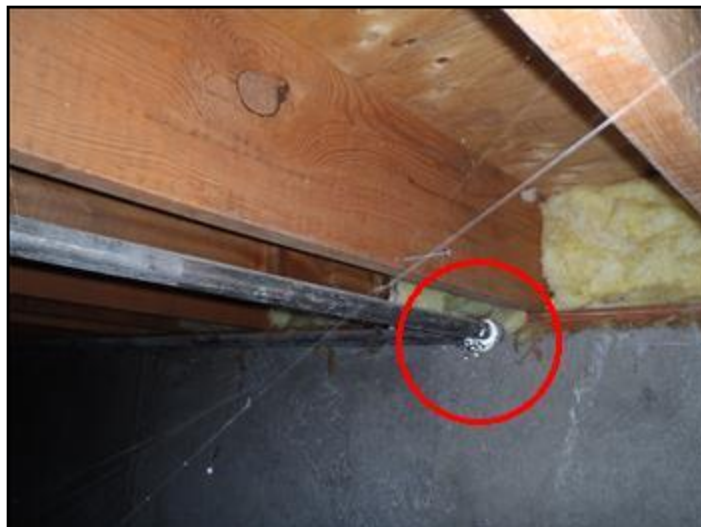
124.

**Condition:** • [Leak](#)

**Task:** Repair

**Time:** Immediate

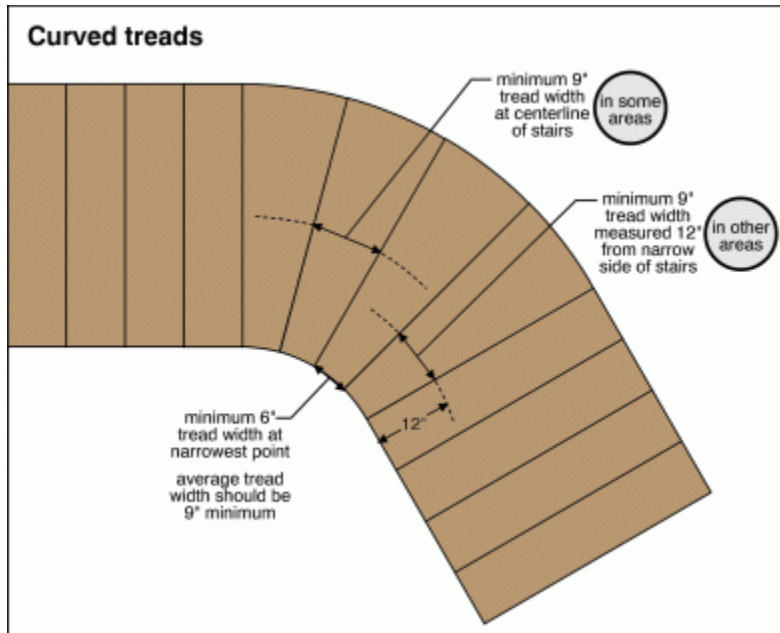
**Condition:** • [Width too small on curved treads](#)

**Implication(s):** Trip or fall hazard

**Task:** Improve

**Time:** Discretionary

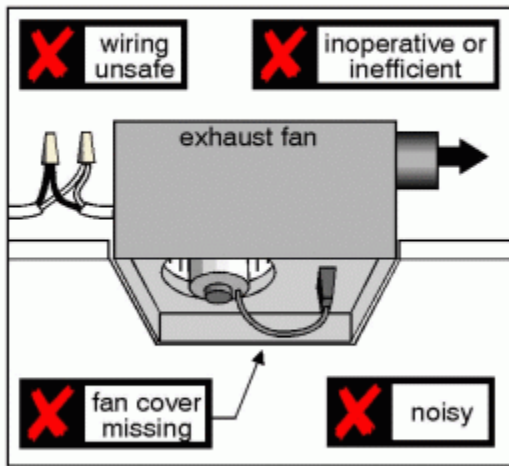
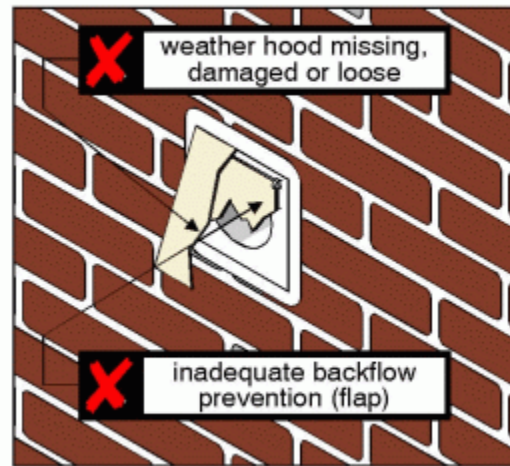
**Condition:** • [Inoperative](#)

**Implication(s):** Chance of condensation damage to finishes and/or structure

**Location:** Bathroom in Addition

### Exhaust fan conditions

**Task:** Improve
