# INSPECTION REPORT

For the Property at:  
**5759 HORSE LK**  
100 MILE HOUSE, BC

Prepared for: JOHN DOE  
Inspection Date: Saturday, February 2, 2013  
Prepared by: Daryl Silverton

Report No. 1346, v.6

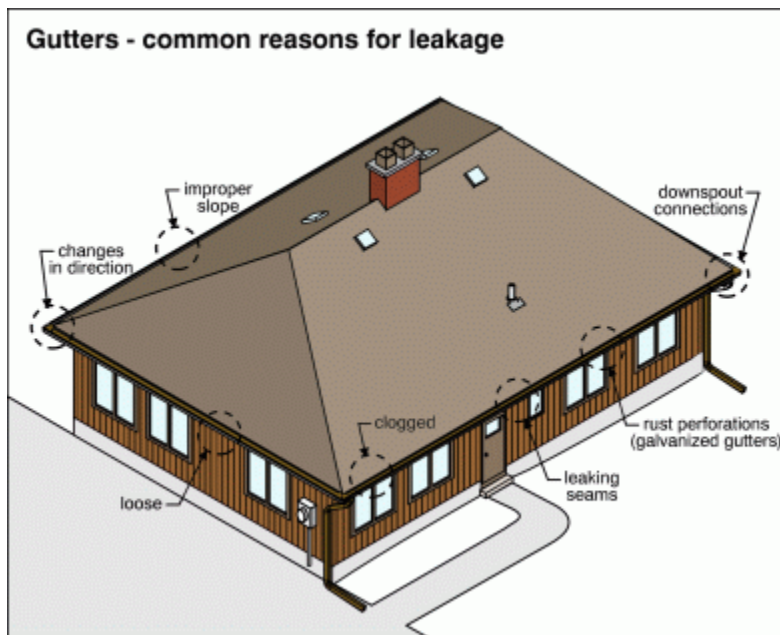
## ROOF DRAINAGE \ Gutters

**Condition:** • [Leak](#)

**Implication(s):** Chance of water damage to contents, finishes and/or structure

**Task:** Repair

**Time:** When remodelling

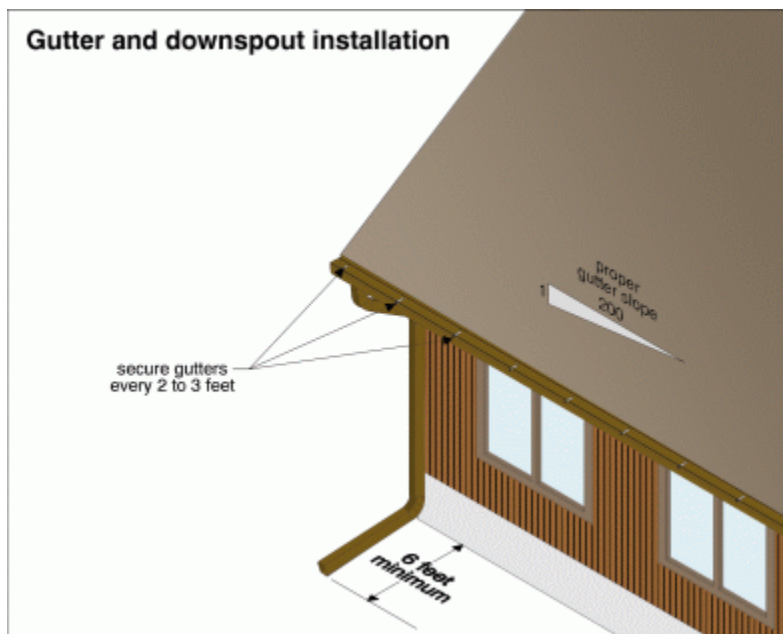
**Condition:** • [Missing](#)

**Implication(s):** Chance of water damage to contents, finishes and/or structure

**Task:** Provide

**Time:** Discretionary

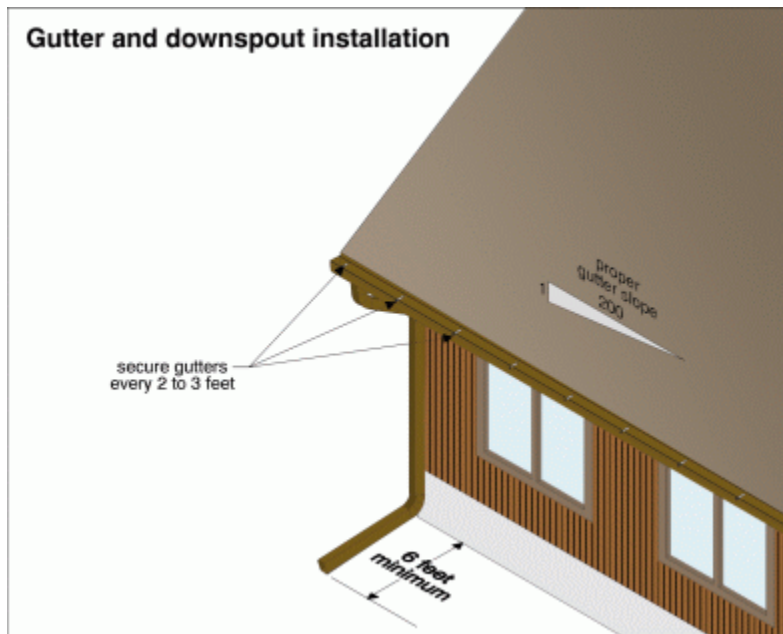
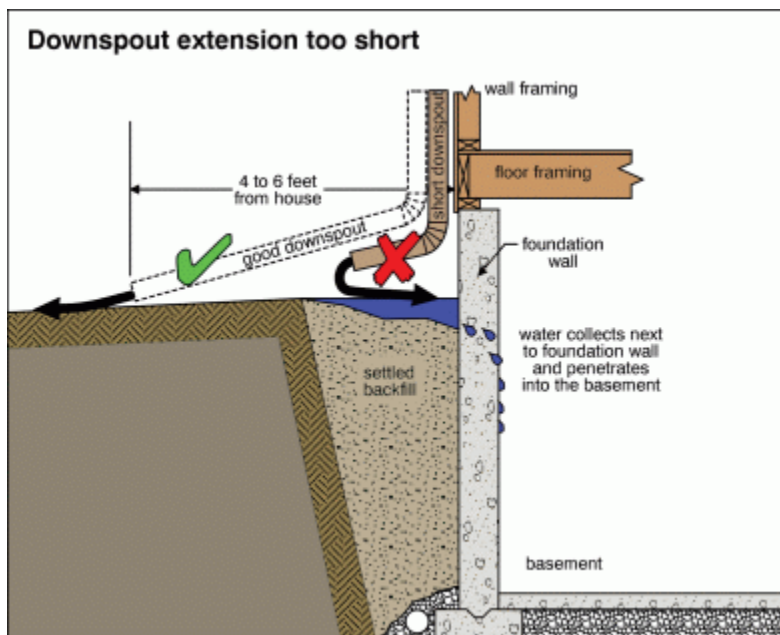
**Condition:** • [Downspouts end too close to building](#)

**Implication(s):** Chance of water damage to contents, finishes and/or structure

**Task:** Improve

**Time:** Less than 1 year

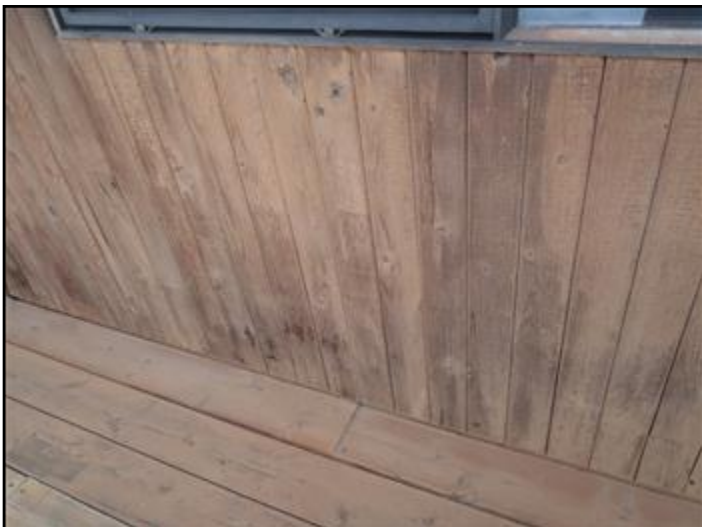
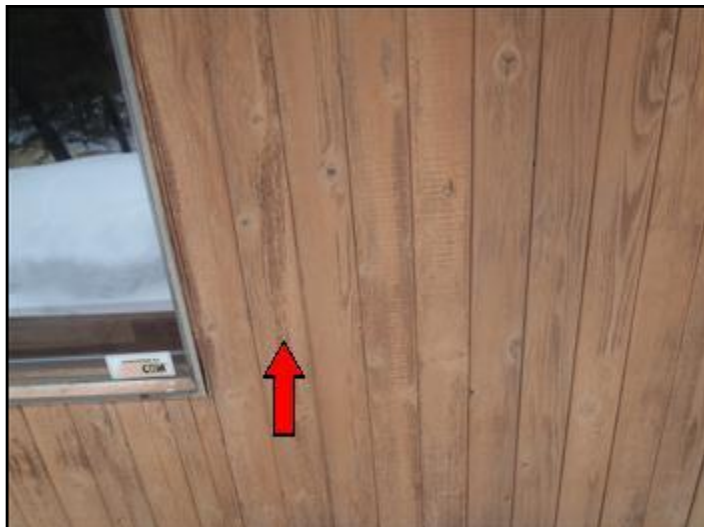
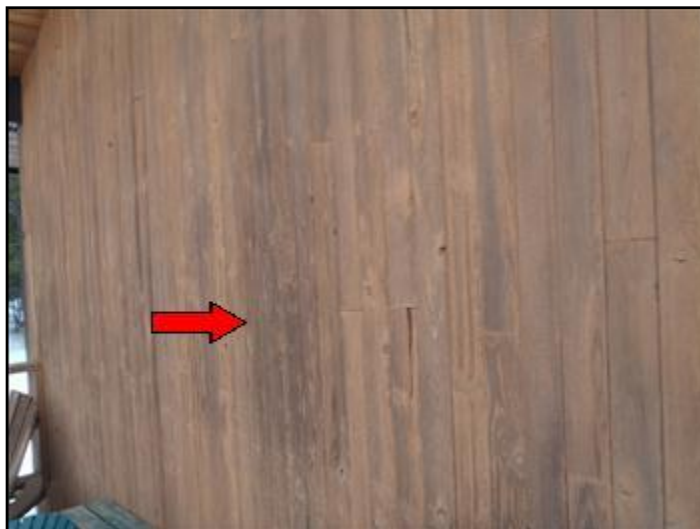
**Condition:** • [Rot or insect damage](#)

**Implication(s):** Cosmetic defects | Chance of water damage to contents, finishes and/or structure | Material deterioration

**Task:** Replace

**Time:** When necessary

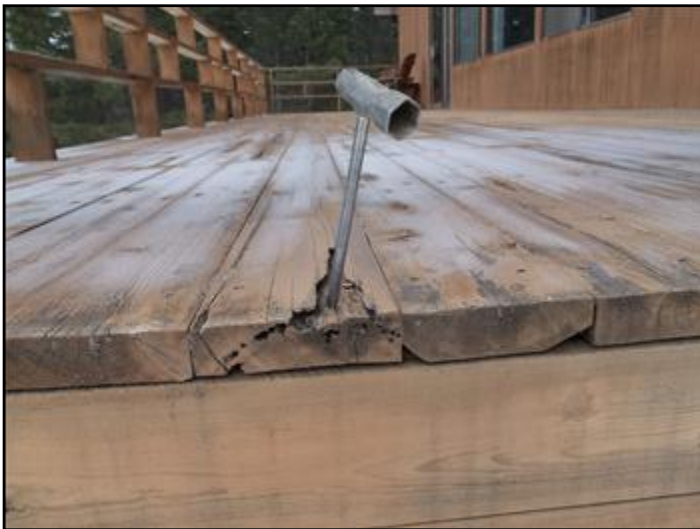
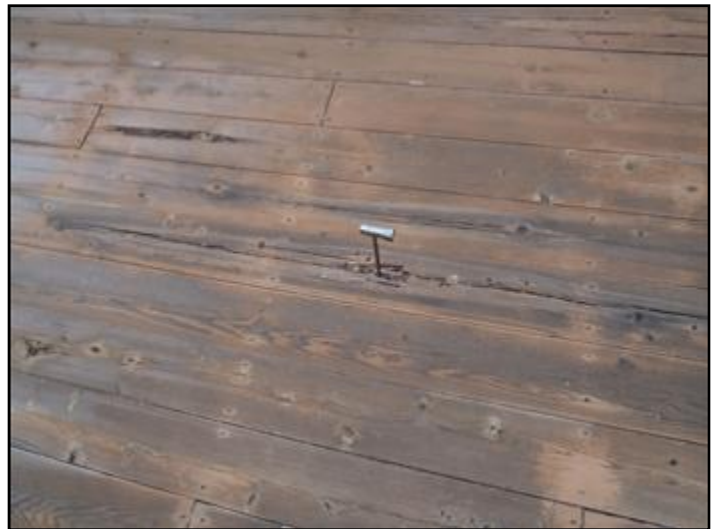
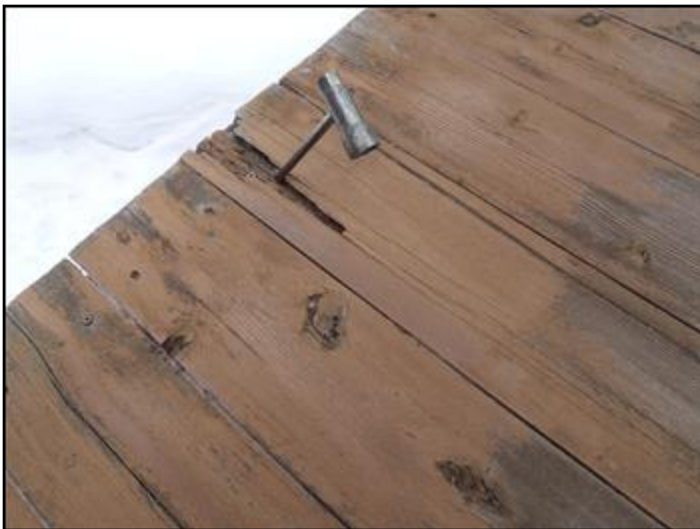
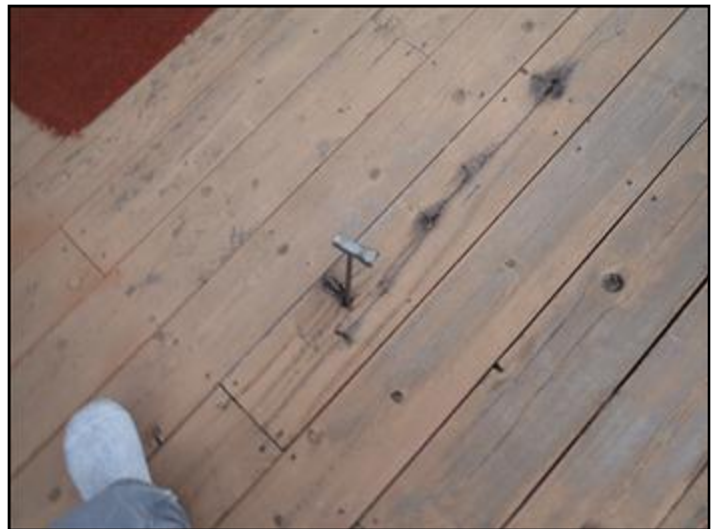
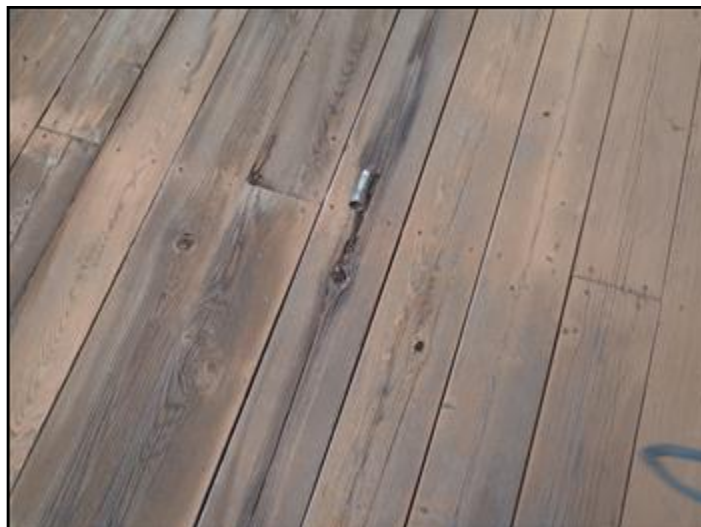
**Condition:** • [Rot or insect damage](#)

**Implication(s):** Weakened structure | Chance of movement | Material deterioration

**Task:** Replace

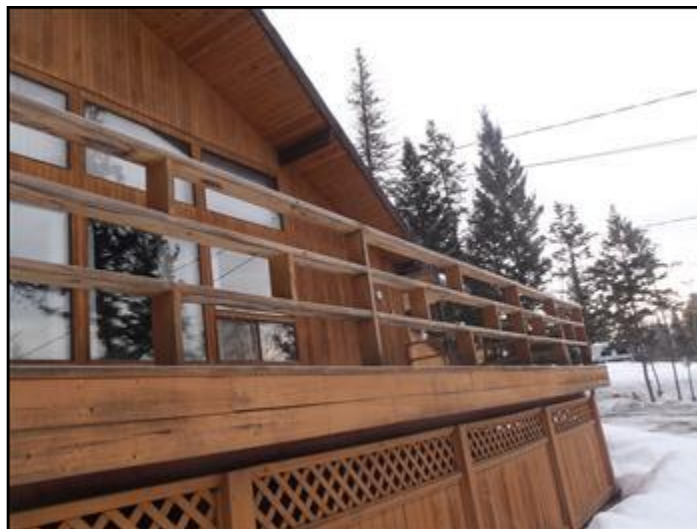
51.

**Condition:** • [Spindles climbable](#)

**Implication(s):** Fall hazard

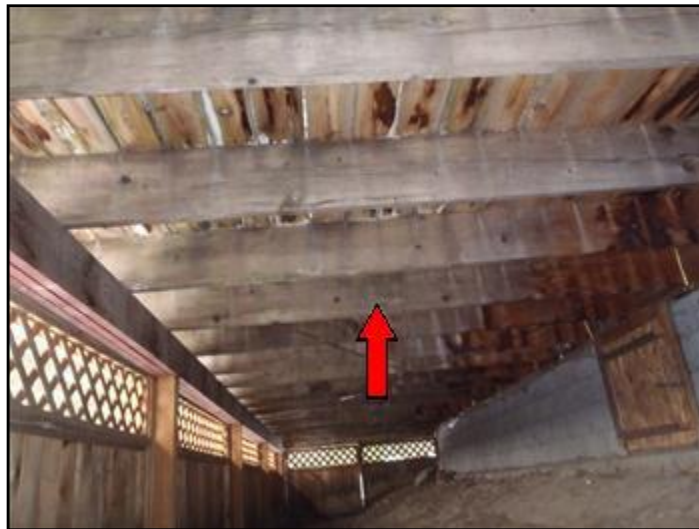
52.

**Condition:** • Paint/ Or Stain

**Task:** Provide

**Time:** Less Than 2 yrs

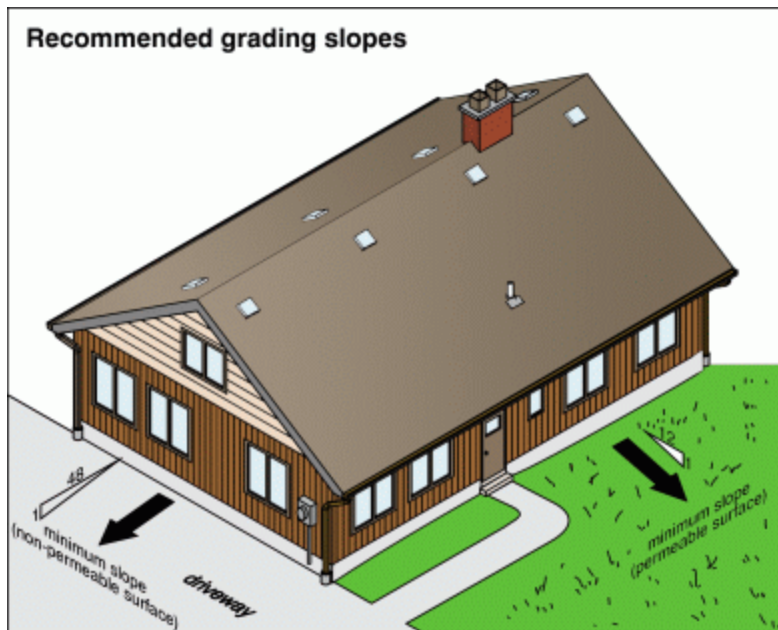
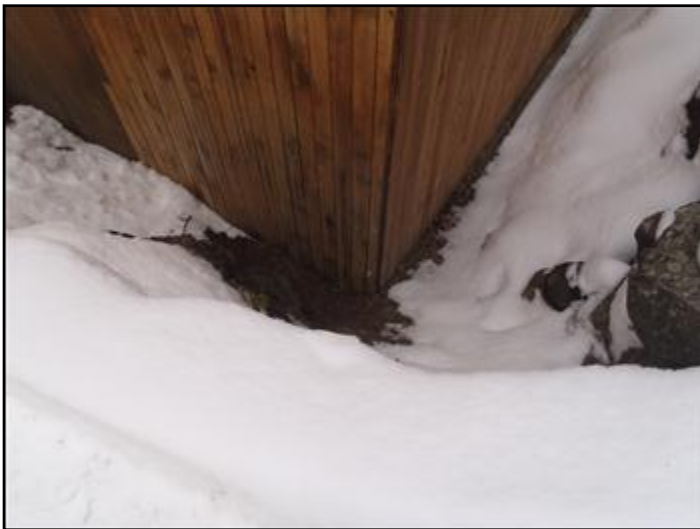
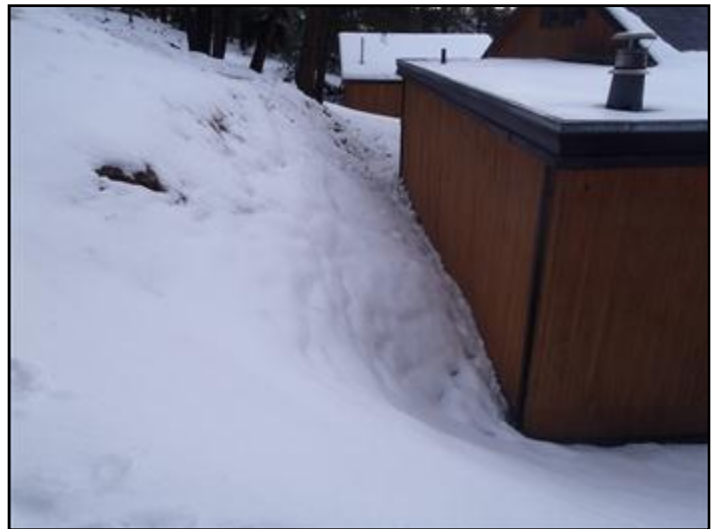
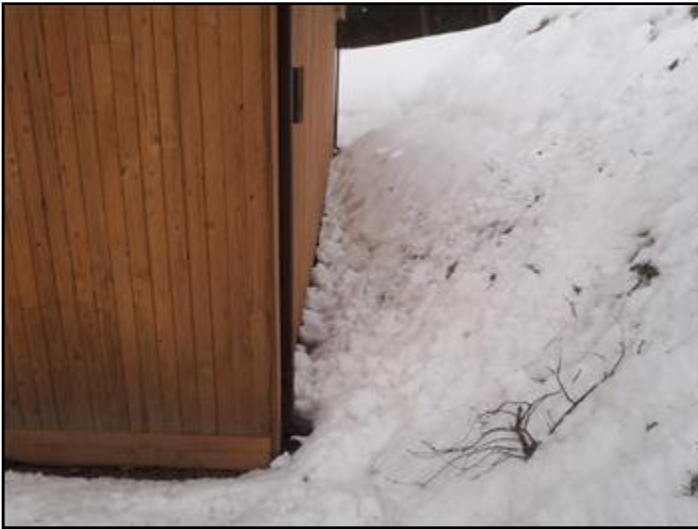
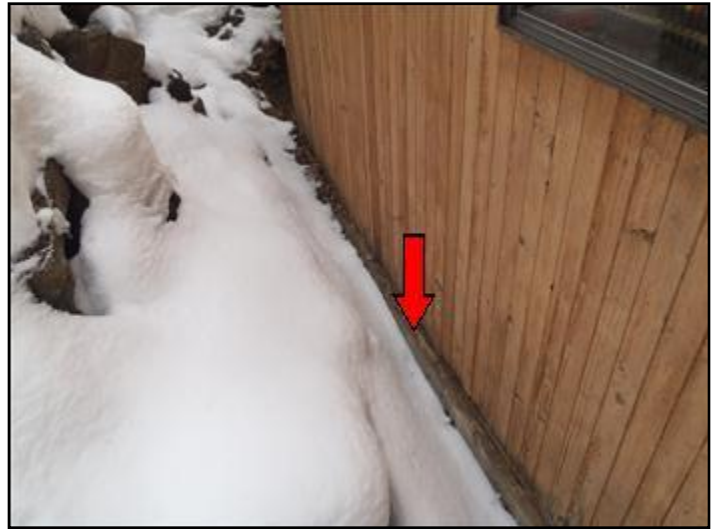
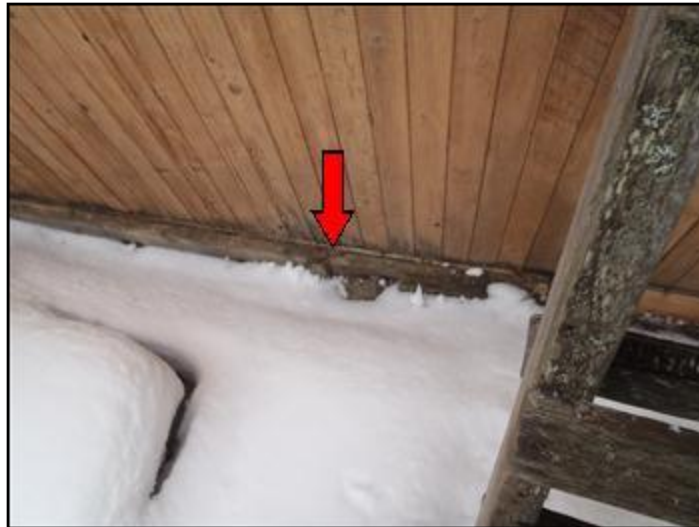
**Condition:** • [Improper slope](#)

**Implication(s):** Chance of water damage to contents, finishes and/or structure

**Task:** Improve

**Time:** Discretionary

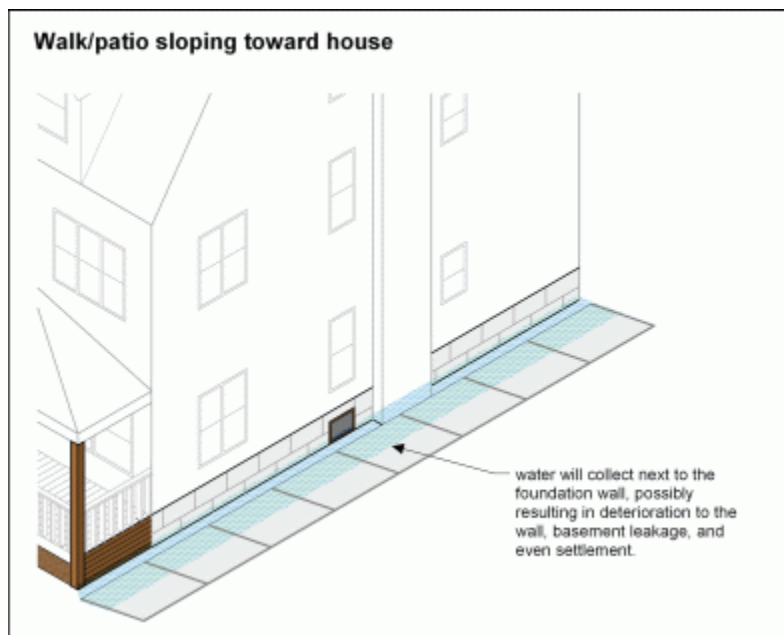
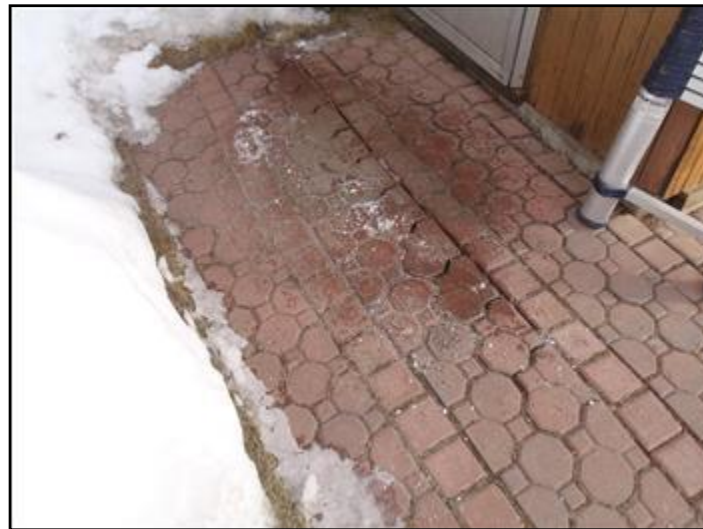
**Condition:** • [Improper slope or drainage](#)

**Implication(s):** Chance of water damage to contents, finishes and/or structure

**Task:** Improve

**Time:** Less than 1 year

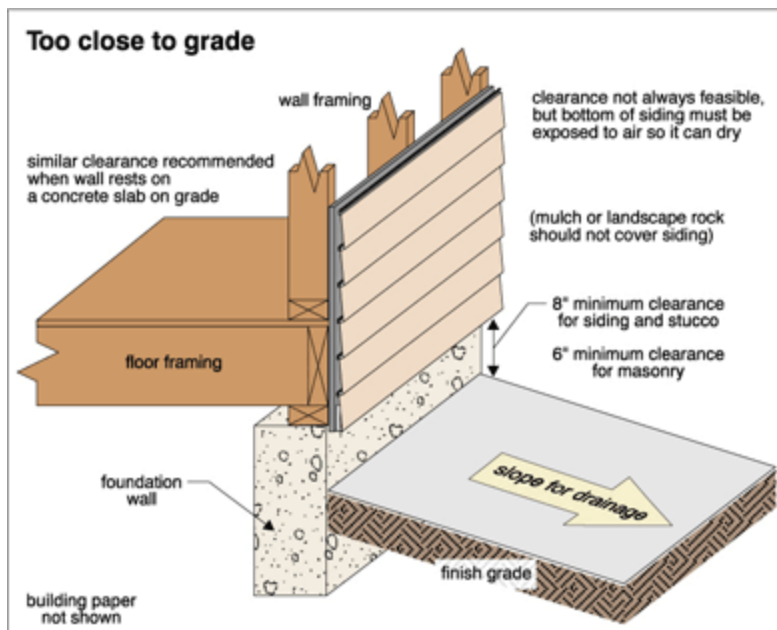
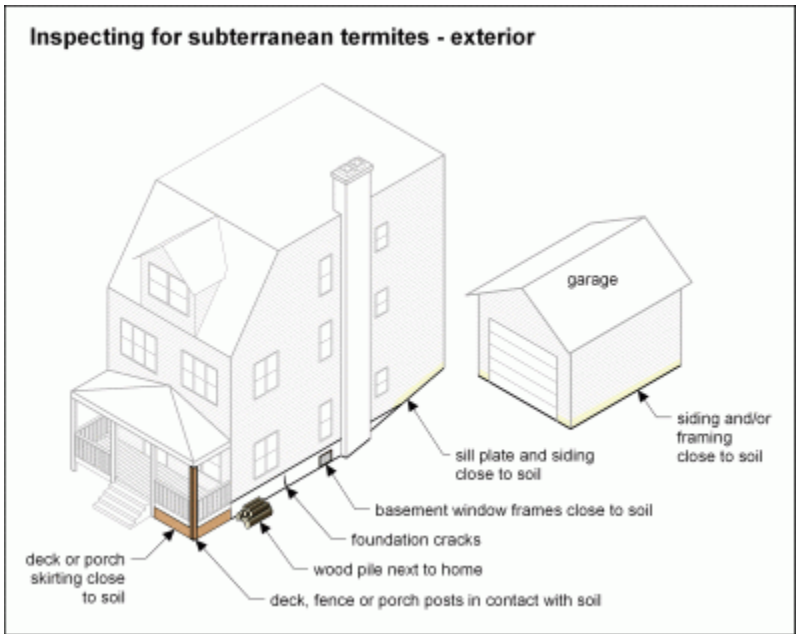
Condition: • [Too close to grade or wood/soil contact](#)

Implication(s): Chance of water entering building | Weakened structure | Rot | Insect damage

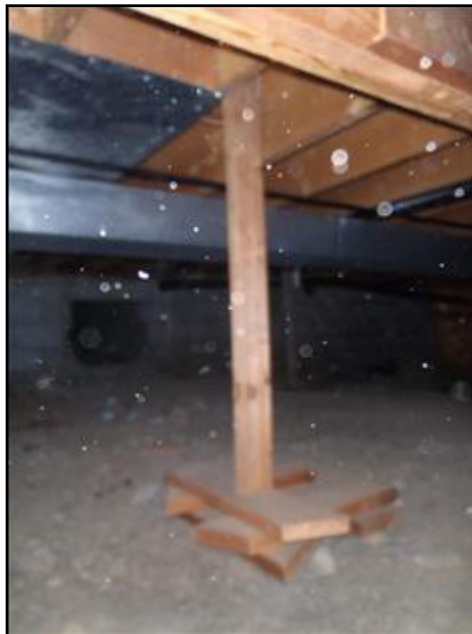
68.

**Condition:** • [No footing](#)

**Task:** Improve

**Time:** If necessary

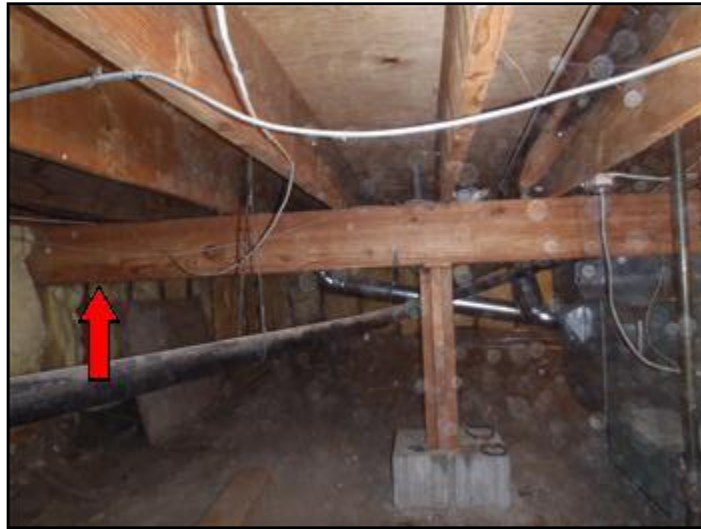
69.

Condition: • [Sag](#)

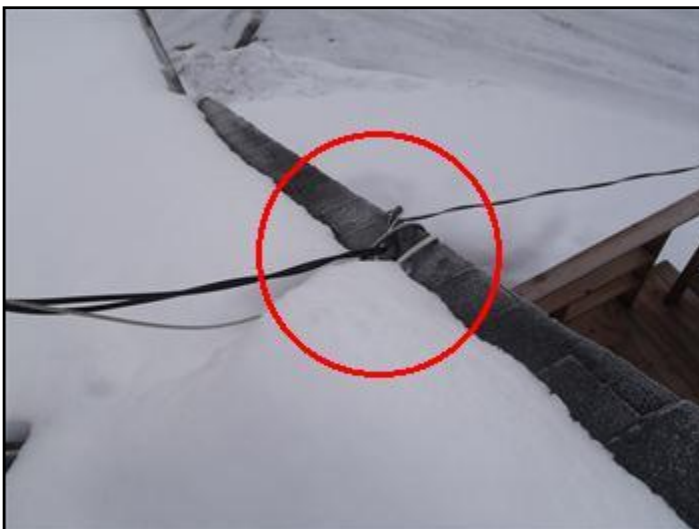
76.

**Condition:** • [Wires too close to roof](#)

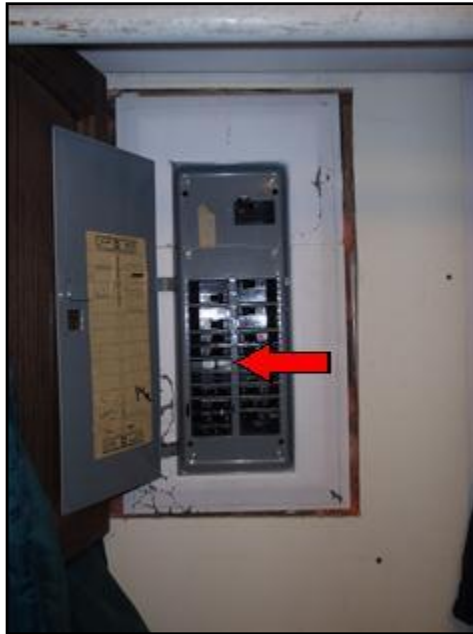
79.

**DISTRIBUTION SYSTEM \ Wiring - installation**

**Condition:** • [Flexible conduit needed](#)

**Implication(s):** Electric shock

**Task:** Provide

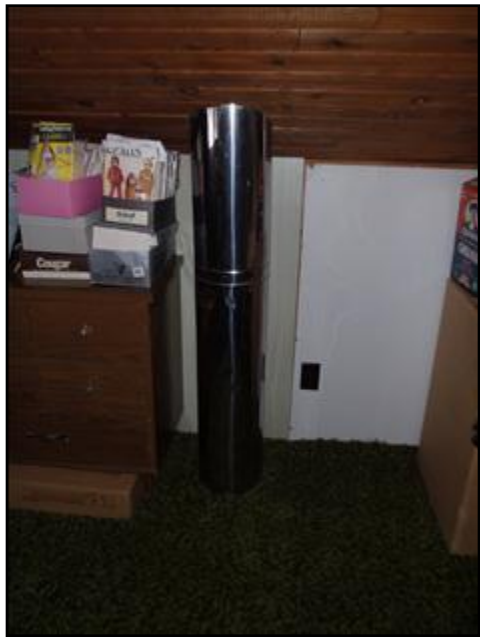
101.

**Condition:** • [Combustible clearance](#)

**Implication(s):** Fire hazard

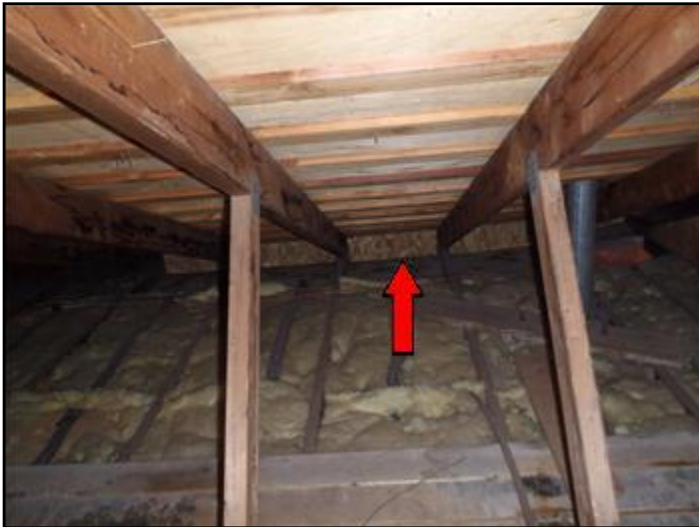
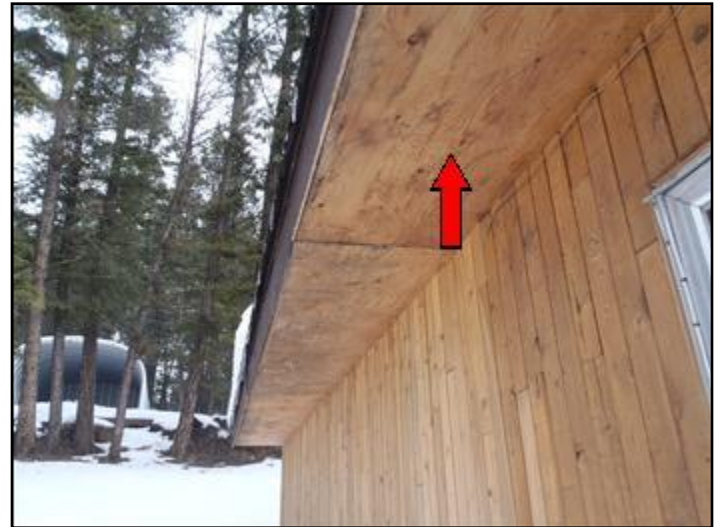
#### Condition: • [Obstructed](#)

**Implication(s):** Chance of condensation damage to finishes and/or structure

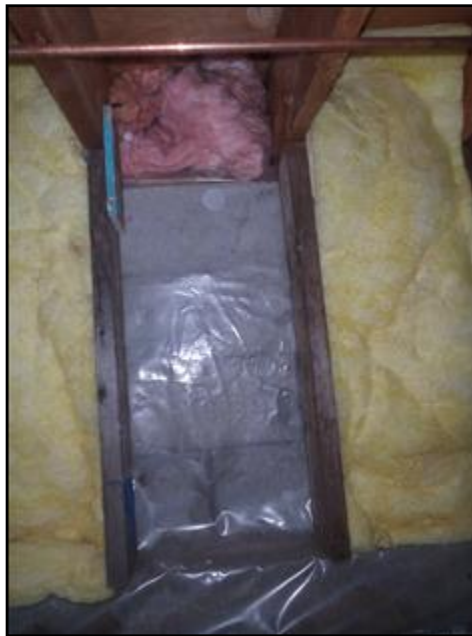
109.

**Condition:** • [None](#)

**Task:** Provide

**Time:** When remodelling

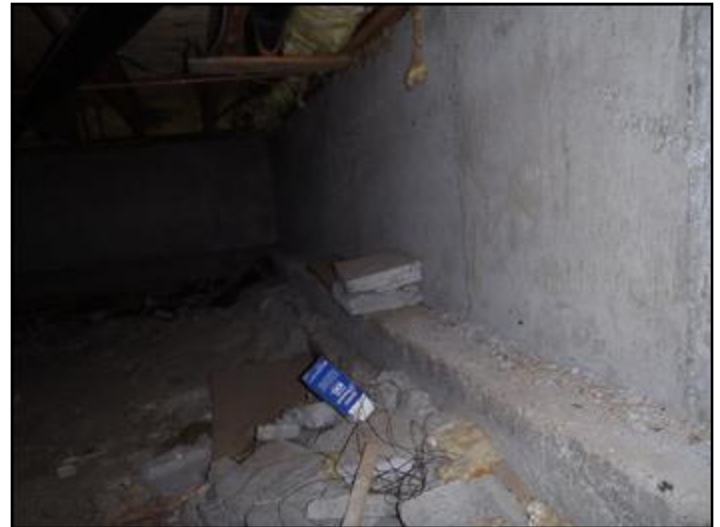
111.

**FOUNDATION \ Crawlspace floor**

**Condition:** • [No vapor barrier](#)

**Implication(s):** Chance of condensation damage to finishes and/or structure

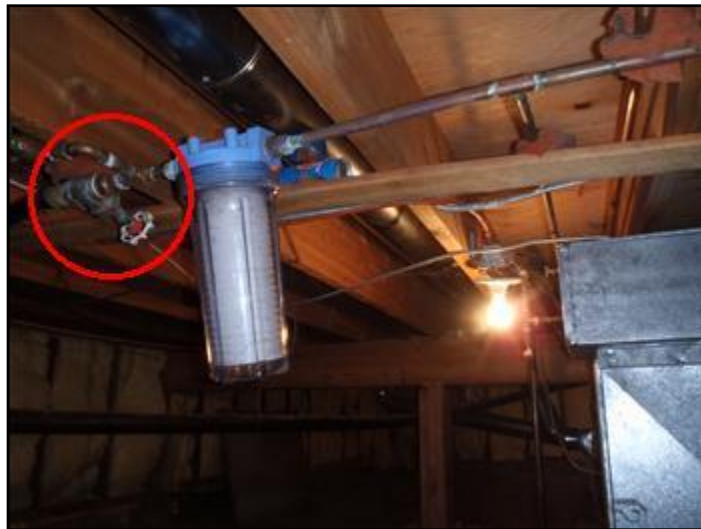
114.

**Main water shut off valve at the:**

• Crawlspace

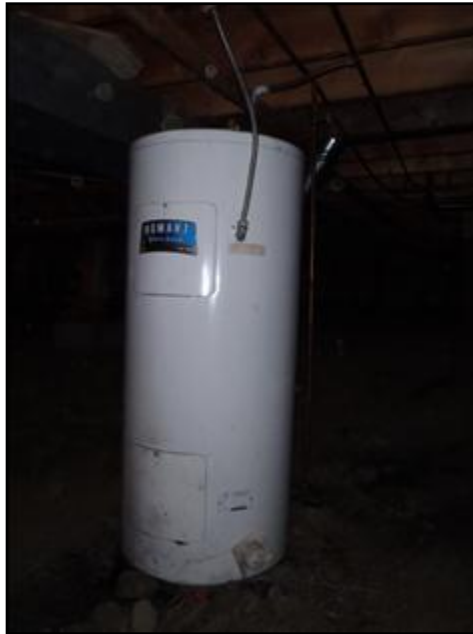
115.

**Water heater manufacturer:** • Homart

**Water heater failure probability:** • [High](#)

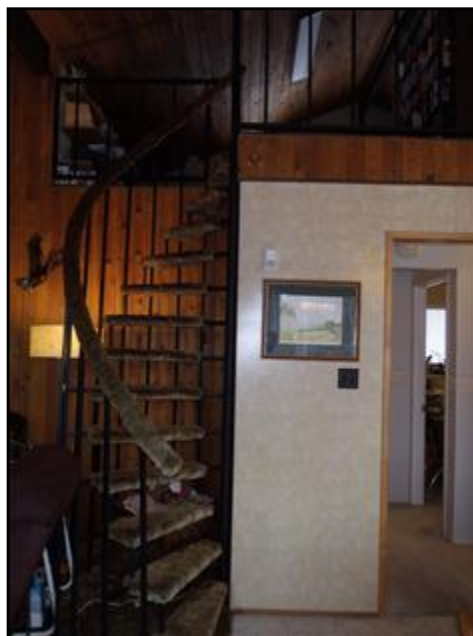
143.

**Condition:** • [Width too small on curved treads](#)

**Implication(s):** Trip or fall hazard

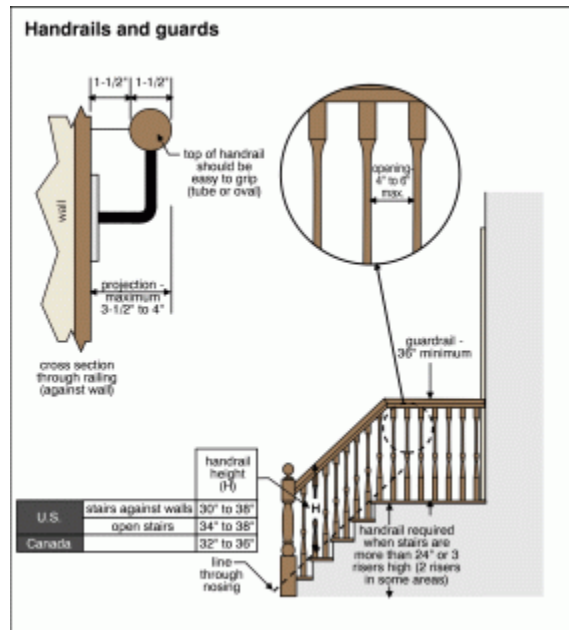
### STAIRS \ Spindles or balusters

**Condition:** • [Too far apart](#)

**Implication(s):** Fall hazard

**Task:** Improve

**Time:** Discretionary
